## Research into in-service deterioration of ball-rolling rolls

**Abstract.** This work features research findings on causes of deterioration occurring in ball-rolling rolls. The causes of such deterioration may originate not only in the excessive loads application and the use of bottleneck operating parameters but also in the specific process being implemented and the equipment used to heat-treat the rolling rolls. The deterioration occurring in roll flanges having a relatively small thickness was used to demonstrate that, to prevent the deterioration of ball-rolling roll flanges, the mill design must accommodate the minimum allowable flange widths obtained as a function of maximum allowable loads and the roll pass calculations. The next example of roll deterioration involved the use of a gas furnace to implement the heating stage of the quench hardening process for rolls made of 35KhGSA steel, which, as a result, developed roll deterioration. The use of rolls of the same steel grade, which were heat-treated in an arc furnace prior to being quenched, has been shown to deliver long-lasting positive results evidenced by many years of their operation. Rolls made of 5KhNM steel have

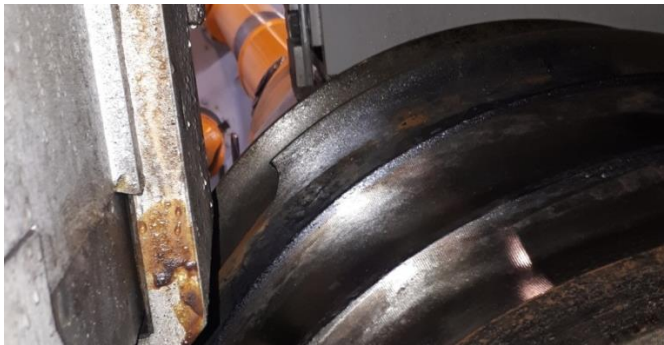
With a streamlined roll pass design solution, the overall wear and tear affecting the flanges will be characterized by the abrasion wear occurring along the working faces of the flanges. When, in particular, the choice of roll material was made in favor of 5KhNM steel and the hardness of the quench-hardened layer was relatively low (38–42 HRC), flange deterioration reached an extent where relatively large portions of it would break off.

**Figure 1.** Roll flange spalling occurring in the neck cutoff zone.

To determine the cause of such deterioration, a 30 × 250 mm sample of the deteriorated flange material that had broken off (Figure 1) from the roll (Figure 2) was taken to be put through a metallographic examination. The hardness of the sample after measurement was 31.5–38.5 HRC which is below the predefined one. The evaluation of microstructure was performed by means of Leica MEF4A optical microscope on 2 sections before and after etching process in 3% alcohol solution of hydrogen nitrate with x50–500 magnification.

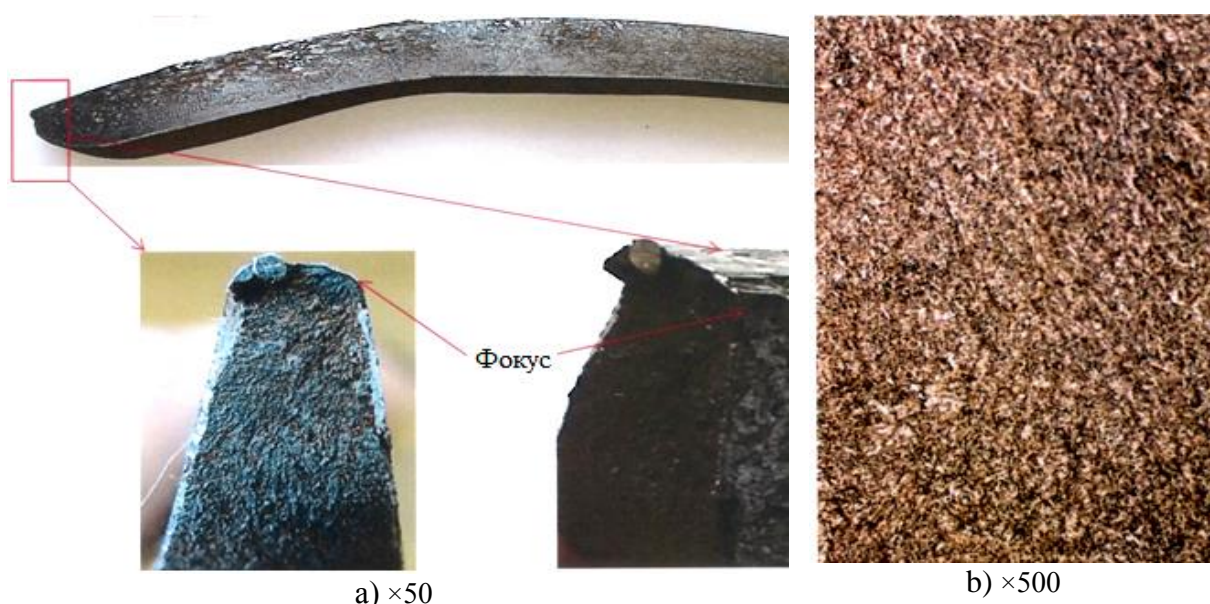
The examination results showed that the base metal used in the roll flange had uniform microstructure and could be identified as tempered martensite (Figure 2, b).

**Figure 2.** Microstructure of the base metal of the flange.

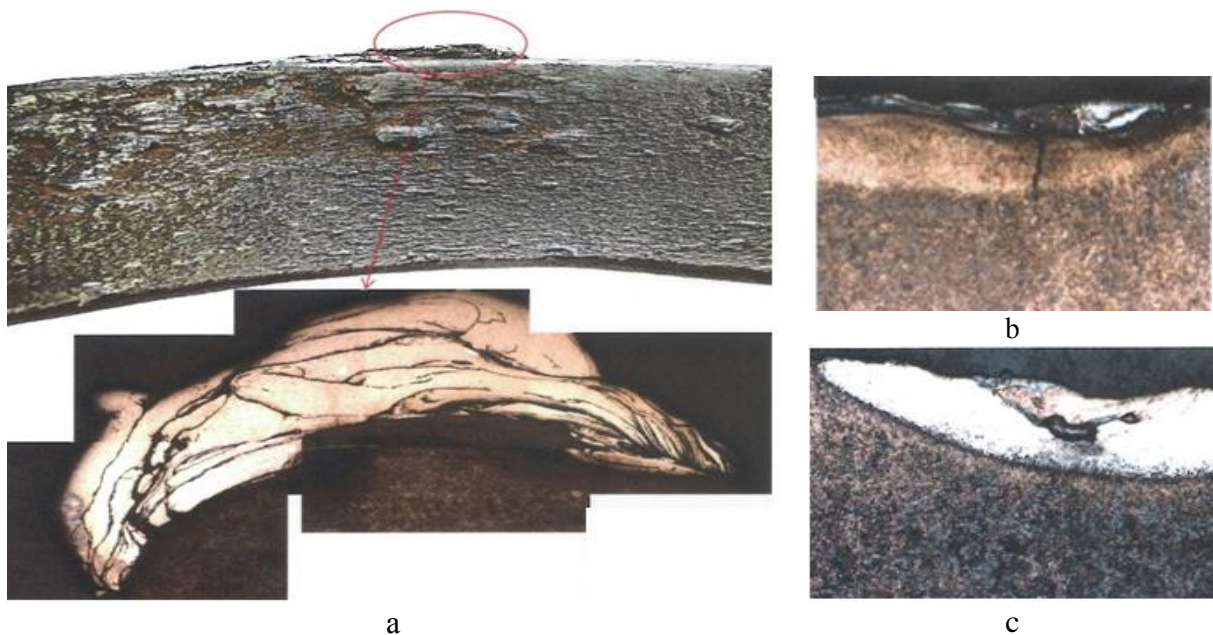
The metal of the rolling work material was welded onto the side surface of the flange and also on the top of it (Figure 3, a.) followed by the separation of a portion of the roll surface, a change in the roll metal structure and the emergence of microcracks (Figure 3, b). White layer of the martensite with the depth up to 0.35 mm was found by the microchemical analysis at the site of focus (Figure 3, c). Nonmetallics, liquation of sulfur and phosphorus at the site of deterioration are absent. In view of the foregoing, it was the adhesion of the hot metal being rolled that caused the deterioration of the flange, as evidenced by the metallic pickup on the side surface and the top of the flange.

**Figure 3.** Microstructure of the flange metal at the side of focus of deterioration:  
a – welded metal of the rolling work material on the top of the flange (x50 magnification);  
b – microcracks and changing of the structure (x100 magnification);  
c – white layer of the martensite (x50 magnification).

In this case insignificant load increase led to the flange overheating because of its low thickness (9.5 mm) and to further deterioration. As a result, the flange thickness is important to the design of ball-rolling rolls.

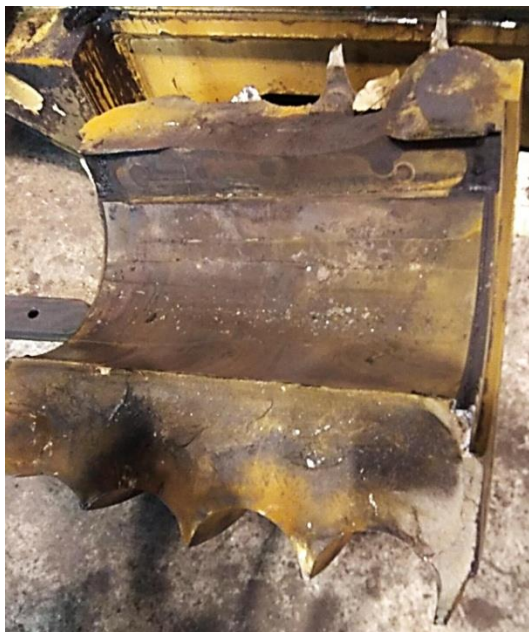
Having excluded any causes attributable to roll pass design and mill setup configurations, other possible causes of critical deteriorations may be the heat treatment conditions used for the steel grades in question. Application of 35KhGSA steel grade in the conditions of JSC EVRAZ NTMK can be a remarkable example. Bodies of ball-rolling rolls made of the mentioned steel have been regularly used during several decades under conditions of the ball section of a Large-structure Rolling Shop where heating up for heat treatment has been carried out using the arc furnace. On a trial basis, the above-mentioned grade of steel was used at the site of ball section of Rail and Beam Shop instead of the 5KhNM steel used there. Heat treatment conditions were identical to the ones for a Large-structure Rolling Shop, but due to unit feasibility the heating was carried out in the gas furnace. The complete deterioration of the roll occurred in the process of the first charging of the rolls and trial rolling. Moreover, the cracks which were the cause of the deterioration, occurred not only along the stress concentrators (keyslots, etc.) but also in parallel to the axis along the whole perimeter (Figure 4). Fractures formed on both sides of punctured part of the roll are fragile, with focuses extending from the surface of the roll-pass. Cross cracks were found on the surface of the flange roll-pass.

**Figure 4.** Rolling roll fracture mode.

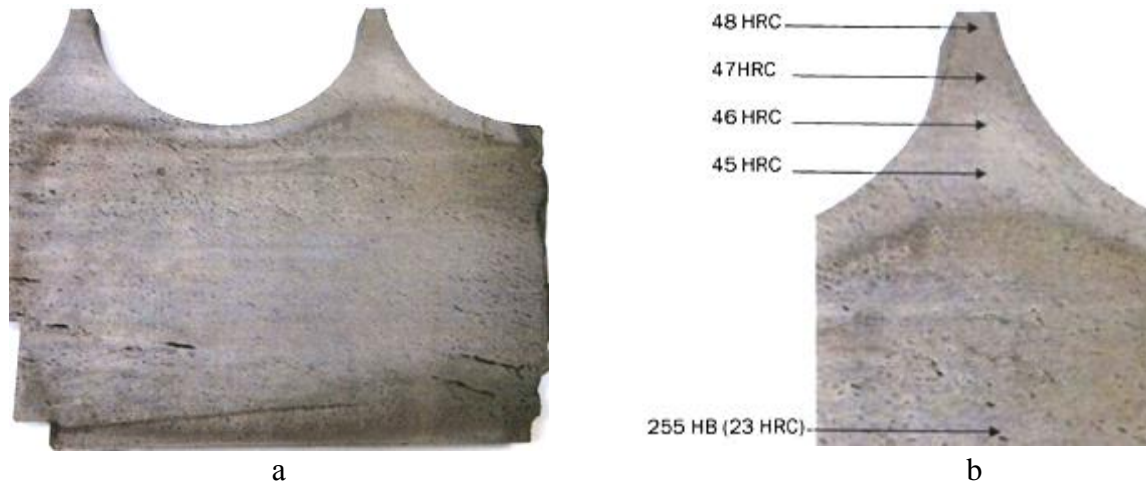
Macroanalysis of the cross section (Figure 5, a) performed by the deep etching method in hot 50% solution of hydrochloric acid showed that the following was found in the deterioration area:

- hardened case extended along the depression of roll-pass to the depth of 10 mm,
- through hardening of the flanges of the roll-pass,
- freckle-type segregation, 3 points according to GOST 10243–75 [13].

Hardness distribution over the roll section is uneven (Figure 5, b) and is from 48 HRC with gradual decreasing to 45 HRC on the surface. Hardness of the base metal measured by Brinell scale was 255 HB.

**Figure 5.** Results of sample macroanalysis.

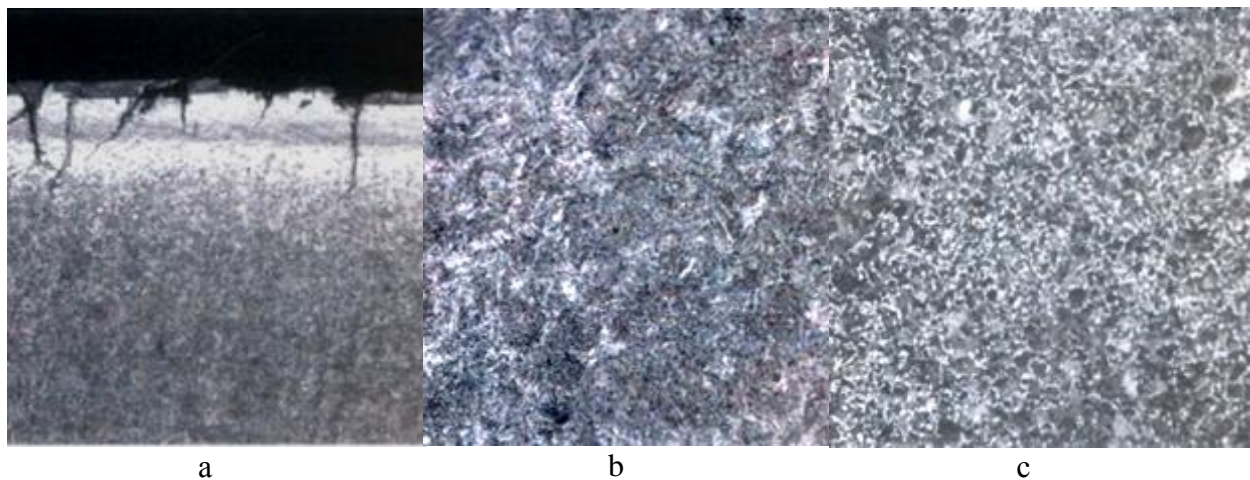
Microanalysis of the roll identified the presence of inadmissible decarburized layer with the depth up to 0.3 mm on the surface of the roll-pass. 15 mm deep thermal cracks and metal chipping along them were detected on one of the lateral sides (Figure 6, a).

**Figure 6.** Sample microanalysis results:

a – hardened case x100, b – hardened case x500, c – base metal x100.

Microstructure of the hardened case extending through the roll-passes represents tempered martensite with sites of retained austenite (Figure 6, b). Structure of the base metal is hypoppearlitic uneven-grained with No. 6–8 grain size according to GOST 5639–82 [14] (Figure 6, c).

As a result of above mentioned, it is possible to suggest that observation of time-temperature modes during heat treatment of ball-rolling rolls is not the only factor that has impact on their further structure including operability, but it is also equipment where heat treatment is performed. Under condition that 5KhNM steel used for ball-rolling rolls of Rail and Beam Shop is not subject to decarburization in the gas furnace, for 35KhGSA steel it was the key parameter that led to the rolls deterioration.
